# Canal Current

A wave of information for Cape Coral's Canalwatch volunteers

Newsletter: 2<sup>nd</sup> Quarter 2021

### The 'buzz' on Beemats Floating Islands

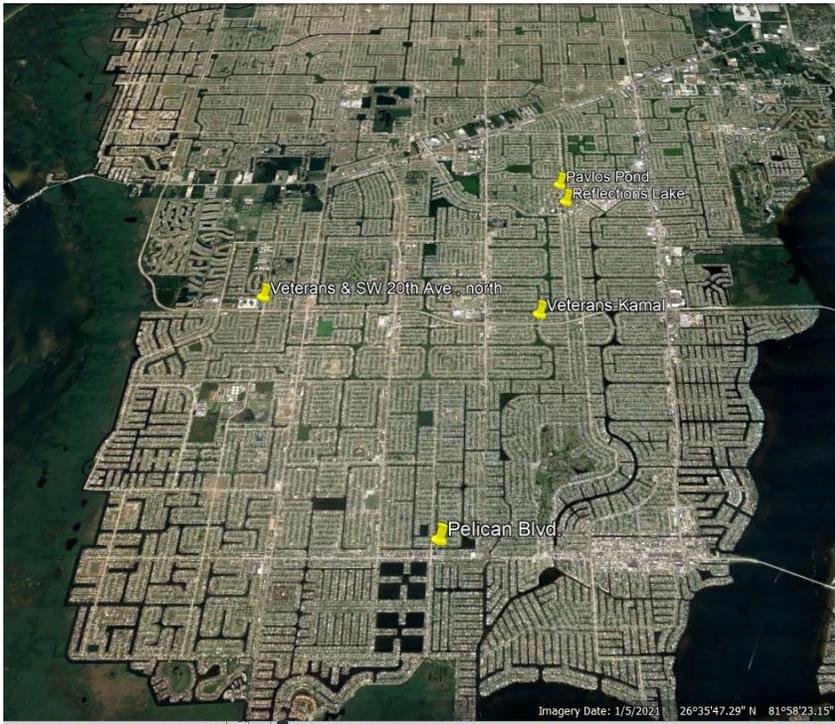
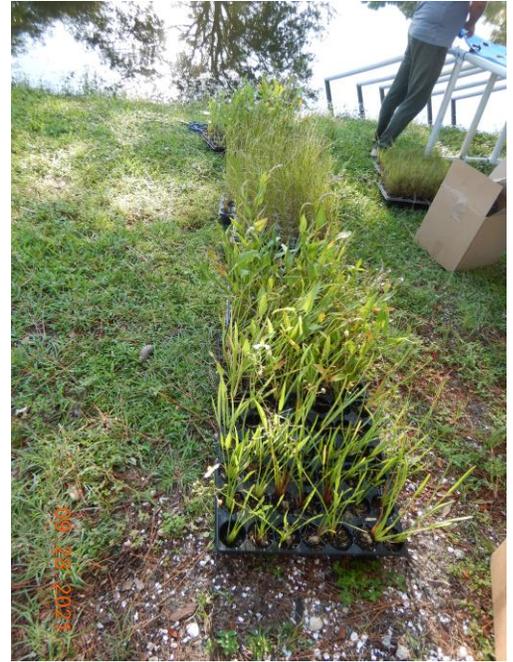
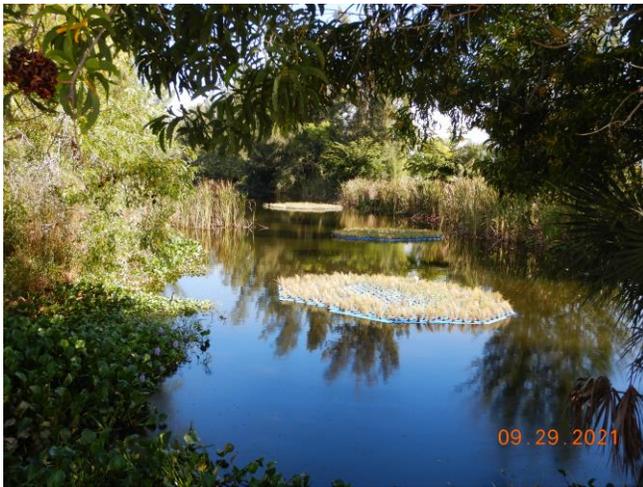
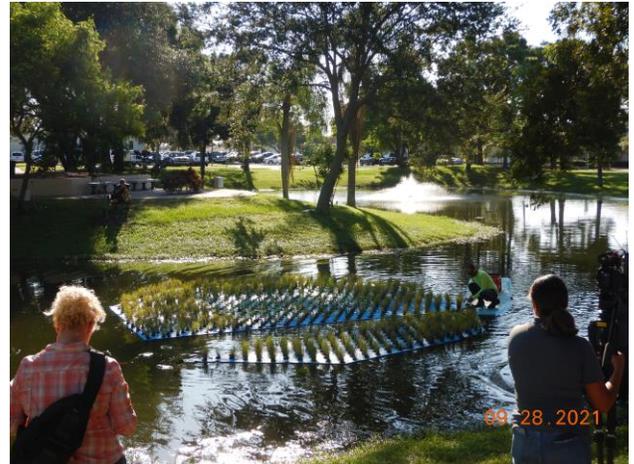
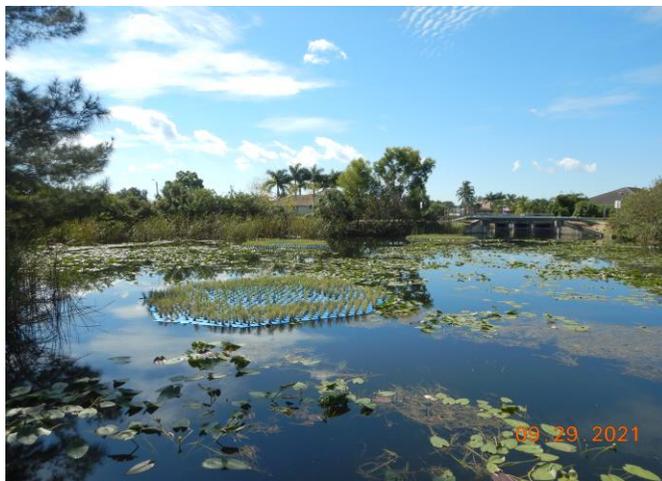
Photos: Kraig Hankins  
 Top left: Map of Beemats locations.  
 Top right: Wetland plants ready for planting.  
 Center left: Beemats at Veterans and SW 20<sup>th</sup> Ave.  
 Center right: Beemat assembly at Reflection Park pond.  
 Bottom: Beemats at Veterans Pkwy and Kamal Pkwy.

such as seawalls. The plantings can be catered towards height, color or wildlife attraction, while incorporating species known for superior nutrient uptake. Plants chosen include pickerelweed, duck potato, canna lily, blue flag iris, rushes & seashore paspalum. Previous studies have shown reductions in nitrogen up to 12% and phosphorus up to 17%.

The floating islands were installed at the end of September in 5 freshwater sites, 4 of which are adjacent to saltwater systems. City staff will assess the amount of nutrients removed, wildlife use, predation on the plants and maintenance costs. If successful, the use of floating islands may be expanded, including in saltwater areas.
