## **Audit Findings Report**

Preformed on 11/18/2025 by Jennifer Muske

Address: 1929 NE 33rd Ter, Cape Coral FL 33909

Permit Number: BRC23-000998

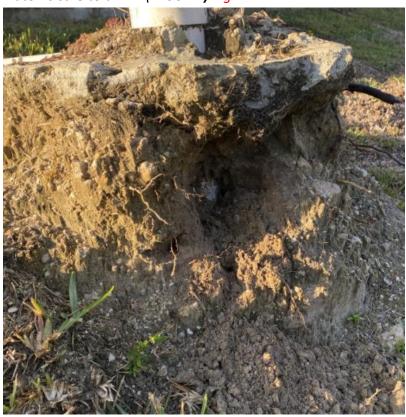
2. Well Potable Water- The well casing has been exposed and is not grouted as per the Lee County Ordnance 06-09. Grouting prevents surface water, bacteria, and other contaminants from seeping down into the well and aquifer. This is vital for ensuring the water is safe to drink. (P2901.1) Fig 2

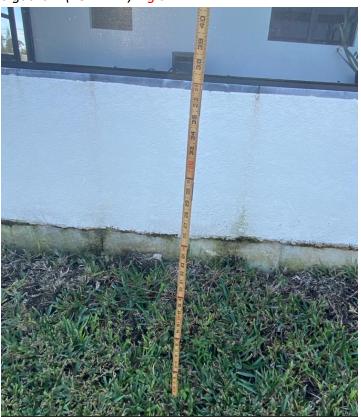
**3. Guardrail**- A guard is required off the back of the pool deck. *Guards* shall be provided for those portions of open-sided walking surfaces, that are located more than 30 inches measured vertically to the floor or *grade* below at any point within 24 inches horizontally to the edge of the open side. Insect screening shall not be considered as a *guard*. (R312.1.1) Fig 3

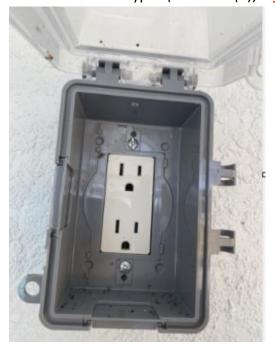
**4. Exterior Electrical-** All 15- and 20-ampere, 125- and 250-volt receptacles shall be listed and so identified as the weather-resistant type. All exterior receptacles are not the weather-resistant type. (NEC406.9(B)) Fig 4

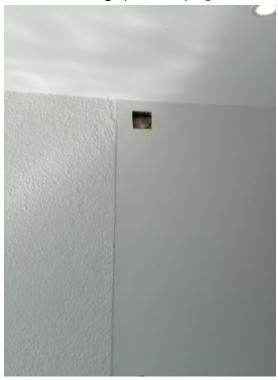
7. Fire Separation Wall- There is a large hole in the fire separation wall between the garage and the dwelling. (R302.5.3) Fig 6

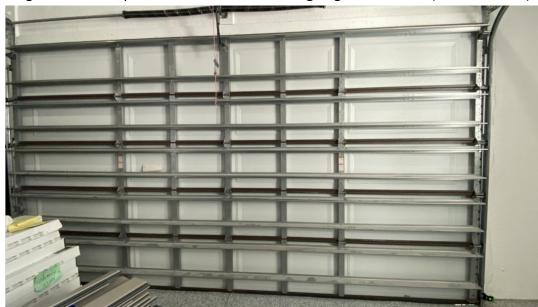
- 8. A. Overhead Garage Doors -The garage doors do not have any labeling to identify Florida product approval number or NOA. This requirement is critical to be able to inspect the installation of the garage doors for our 160mph wind zone. Per the Florida Building Code: Garage doors shall be labeled with a permanent label provided by the garage door manufacturer. The label shall identify the garage door manufacturer, the garage door model/series number, the positive and negative design pressure rating, indicate impact rated if applicable, the installation instruction drawing reference number, the Florida product approval or Miami-Dade product approval number if applicable, and the applicable test standards. (R609.4.1) Fig 5

- **B. Overhead Garage Doors** This overhead garage door appears to be (2020 FL#31372.5 or 2023 Fl#31372.11 drawing number IRC-6216-130-15) and may be missing half of the hinges that are required to be installed on the garage door stiles. (FBCA110.3.13) Fig 5

- **16.** The overhead garage door appears not match the Florida product approval number on the city approved plans. (Amarr door installed, FL#31372.5 vs. Overhead Door Company FL#32170.17)
- **17.** All the windows and doors do not match the Florida product approval numbers on the city approved plans. (Mr. Glass windows are installed, the Florida Product Approval numbers on the city approved plans are a PGT window)
- **18.** The kitchen layout shows a freestanding Range installed; a cooktop is installed in a cabinet base.
- 19. Pre plumb in office with water supply lines and drain are not identified on the plans.

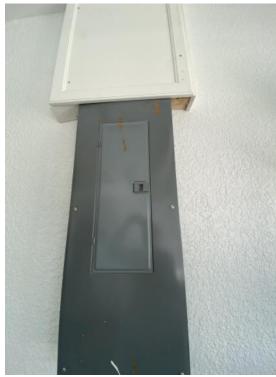
Fig 7

**9. Garage Electrical Panel** – Cabinet door used to cover wire chase is blocking the front of the dead front assembly from being removeable and is not allowed in front of the dead front. *(NEC110.26) Fig 7*

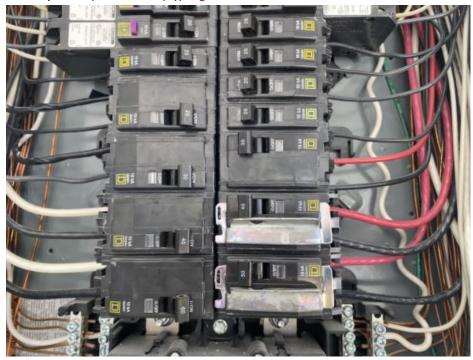
Fia 8

**10. Garage Electrical Panel – Conductor Identification** – Reidentify ungrounded conductors in the panel. (NEC 210.5(C)) Fig 8

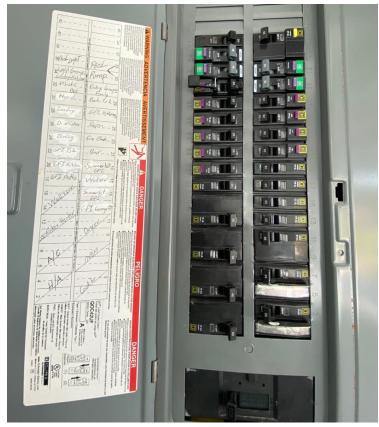
Fia 9

**11. Garage Electrical Panel – Fireplace** – A lockable means of disconnect is required for the fireplace. (NEC 422.31) Fig 9

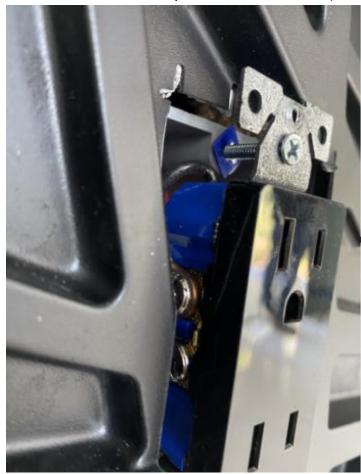
**12. Kitchen Island**— The receptacles on the front of the island are not installed in a junction box and are surrounded by combustible material. (NEC 406.5) Fig 11

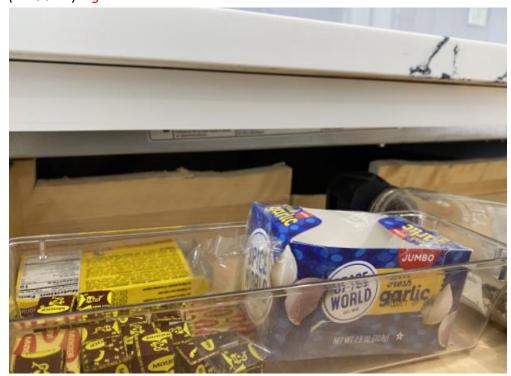
**13. Kitchen Cooktop – Clearance** – Please refer to manufacture specification, a minimum of 5¾ inches clearance is required between the bottom of the cooktop and combustible materials. A drawer is currently installed directly below and nearly touching the cooktop. (M1901.2) Fig 12

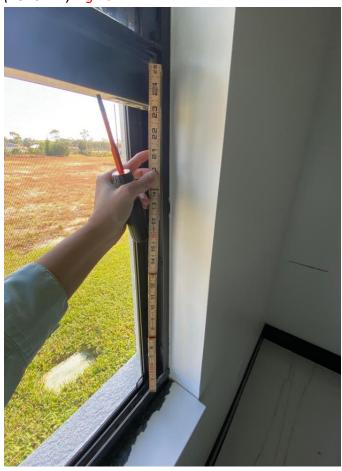
14. Emergency Escape Openings- Windows in bed 2 & 3 do not have a 24" clear opening.
(R310.1.1) Fig 13

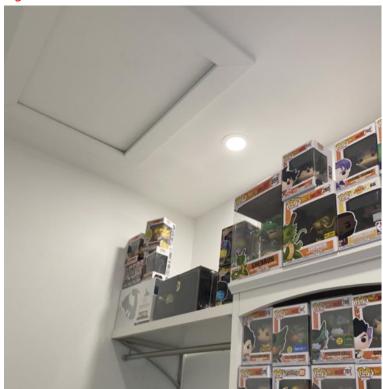
**15. Master closet-** The minimum clearance between recessed LED luminaires installed in clothes closets and the edge closet shelf shall be 6 in. (NEC410.2 & NEC410.16(C)) Fig 14
